# **SEISMIC, ACOUSTIC, AND MAGNETIC TEST RESULTS FROM US/GERMAN TESTING**

**John Sledge  
CHICKEN LITTLE Program Office  
Eglin AFB Florida 32542**

Seismic, acoustic, and magnetic (SAM) sensors are passive devices that play an important role in identifying vehicular features of military interest. This was the case during a recent joint (US/GERMAN) test at the Meppen Test Facility, Meppen, Germany. The test consisted of detonating a HARM missile warhead in close proximity to a SA-6 and other support vehicles. SAM sensors were deployed in the far field to simulate a probe that had penetrated to a depth of one meter below the ground surface. The discussion begins by describing the SAM sensors and their deployment in the field. A dialogue of signatures and their point of origin follows. SAM signature data will show the health of an operating SA-6 and its subsequent degradation, as monitored by the buried sensors, after detonation of the HARM warhead. Conclusions will depict how the correlation of SAM data can lead to a robust signature product for remote smart probes.

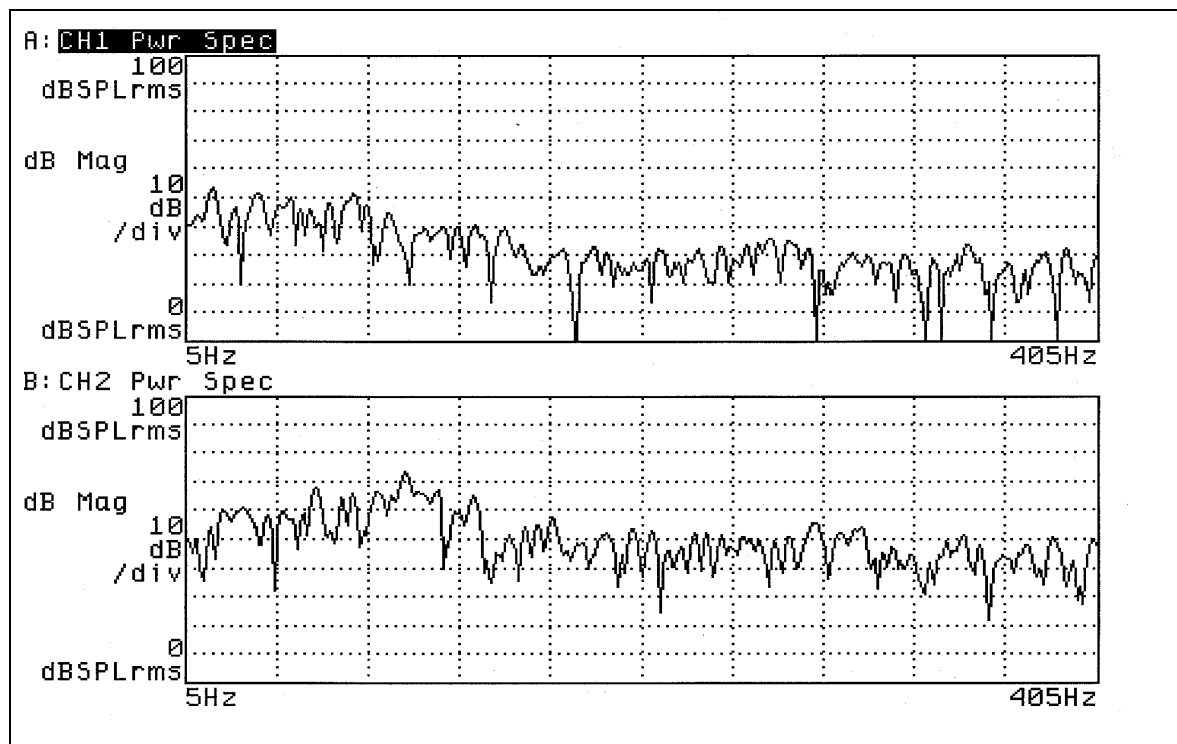
These were found to be higher than expected. It is preferred to work with noise levels of 40dB or less. The background noise levels at the site averaged 50dB. Figure 3-1 shows the background noise levels from microphones M-1 (buried) and M-8 (surface). Noise created by the wind, natural phenomena, and man made easily couples into the ground and can be sensed by microphones.

**Figure 3-1 Acoustic Background Noise Sample from Microphones M-1 and M-8 Respectively**

**4.1.1 Acoustic:** Background noise levels at the site averaged 50dB. Despite these levels, good data samples were acquired.

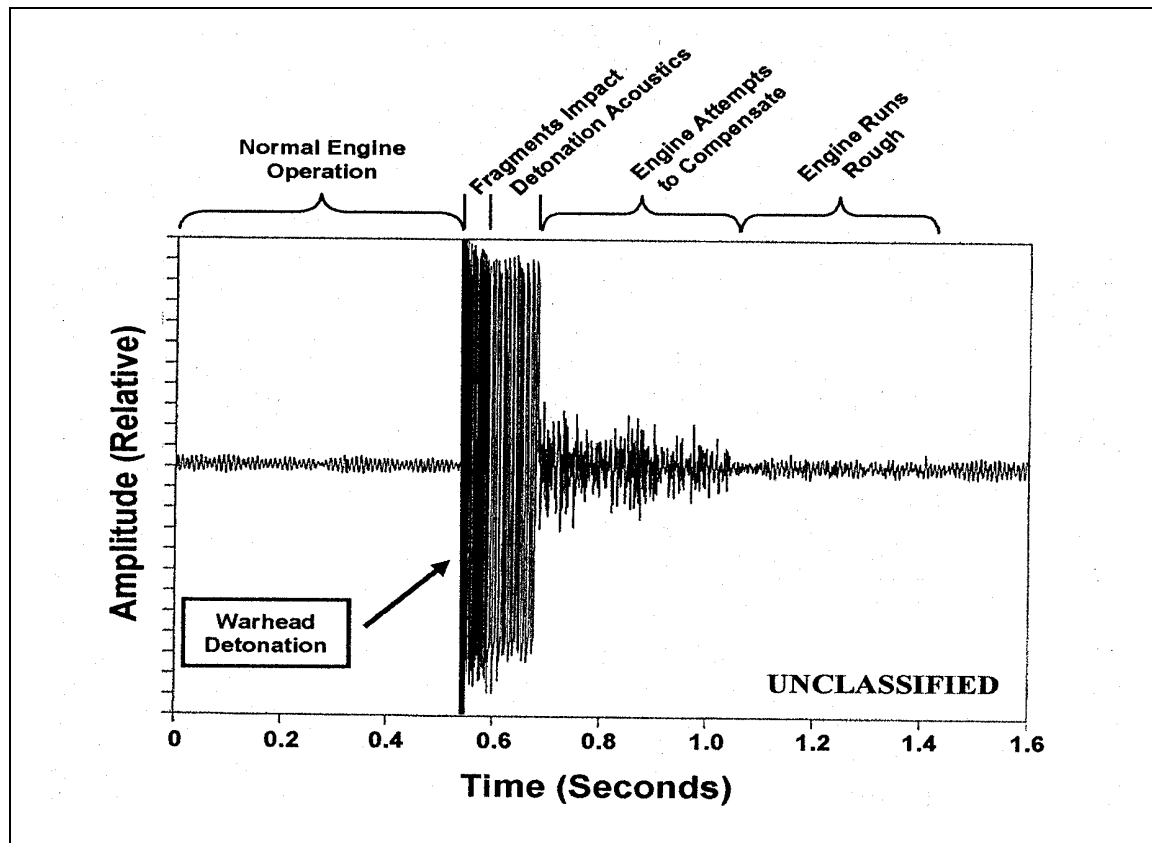
Prior to doing any data analysis it is advisable to look at the analog data stream in the time domain. This is necessary so that a time history of the events can be placed in perspective. Figure 3-2 shows this. The data from microphone M-1 was used for this purpose.

**Figure 3-2 Acoustic Data from Microphone M-1 Shows Signal Time History**

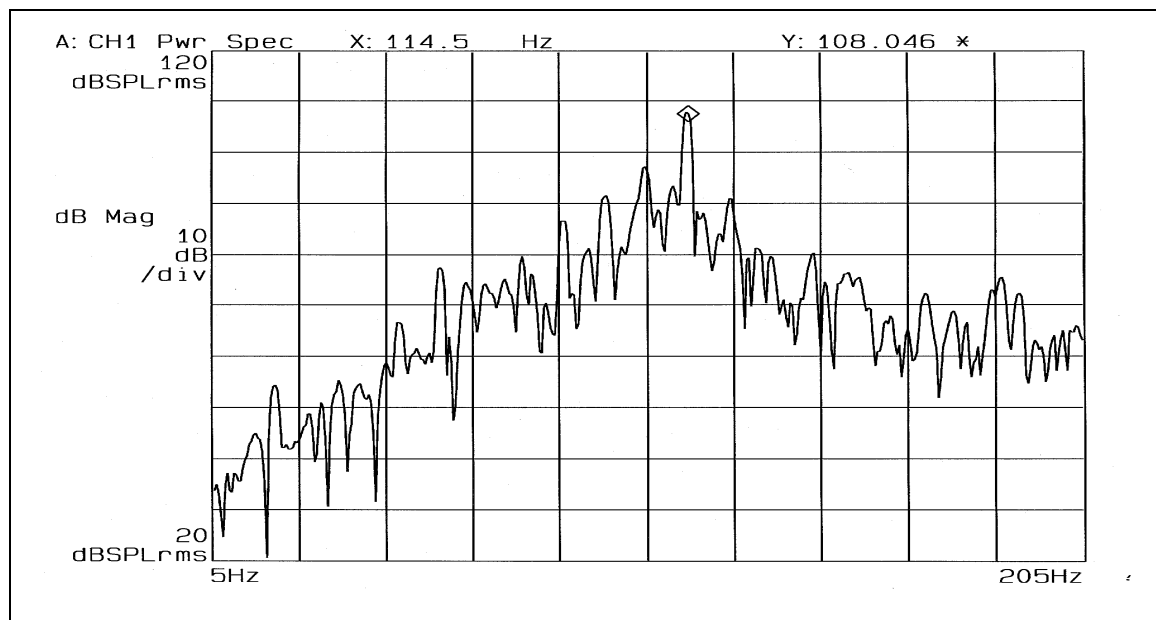
Acoustic data from the SA-6 Radar vehicle shows that the engine firing frequency has an average value of 114.0 Hz and the sound pressure level for this point is 108.0dB. Sound pressure level values vary with the microphone sensitivity. These values were typical of the buried microphones M-1, M-2, and M-3. This is reflected in Figures 3-3, 3-4, and 3-5 respectively. The pyramid shaped harmonics result from wind noise and the soil inherent filter properties. These have an affect on the frequency components of the acoustic spectra.

**Figure 3-3 Acoustic Data Sample from Microphone M-1 Shows SA-6 Radar Vehicle Engine Signature Prior to Warhead Detonation.**

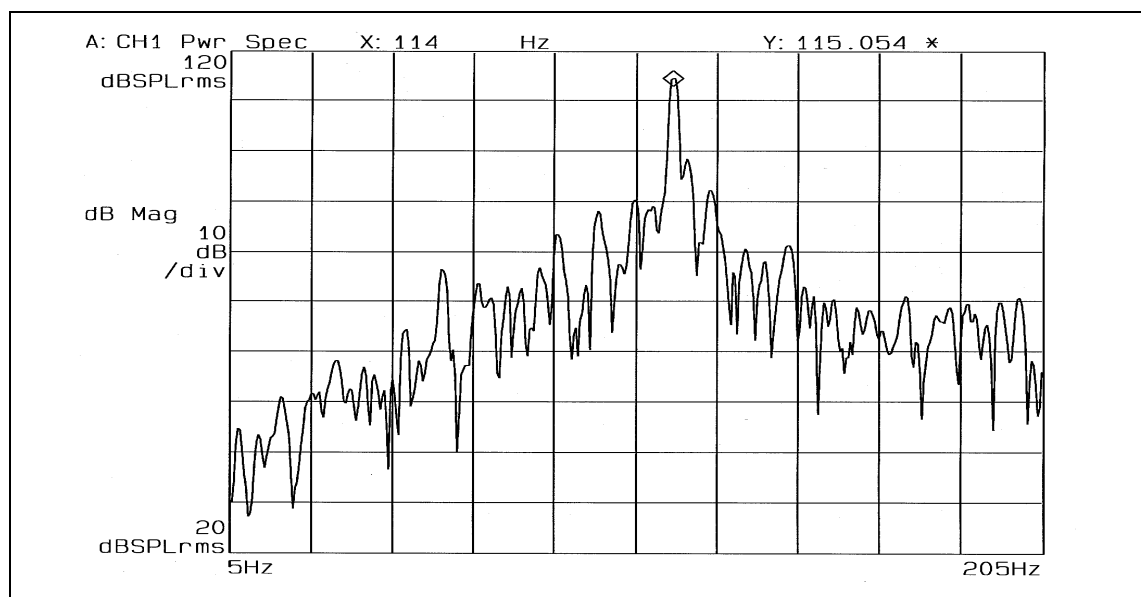
**Figure 3-4 Acoustic Data Sample from Microphone M-2 Shows SA-6 Radar Vehicle Engine Signature Prior to Warhead Detonation.**

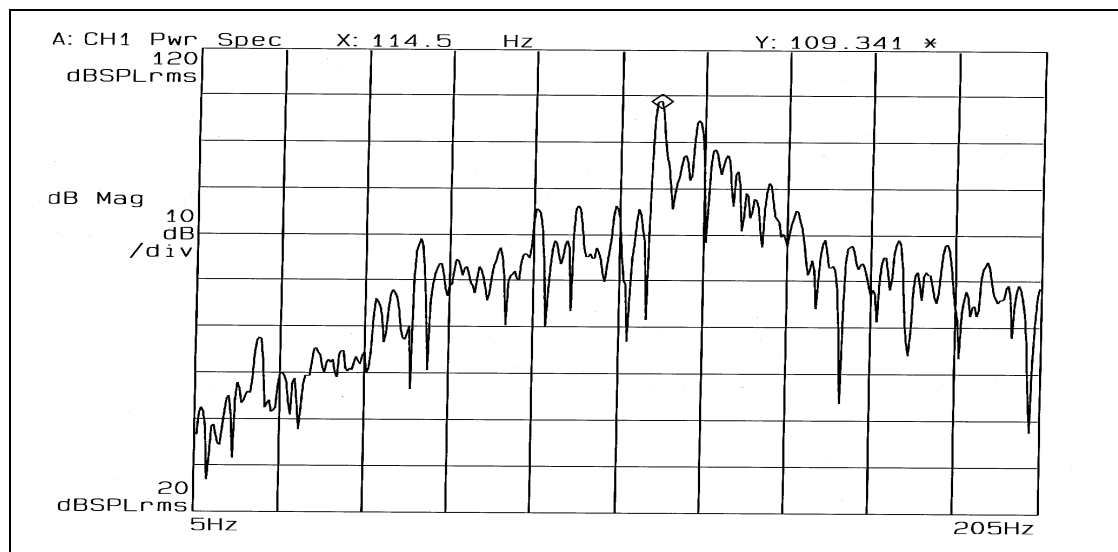
**Figure 3-5 Acoustic Data Sample from Microphone M-3 Shows SA-6 Radar Vehicle Engine Signature Prior to Warhead Detonation.**

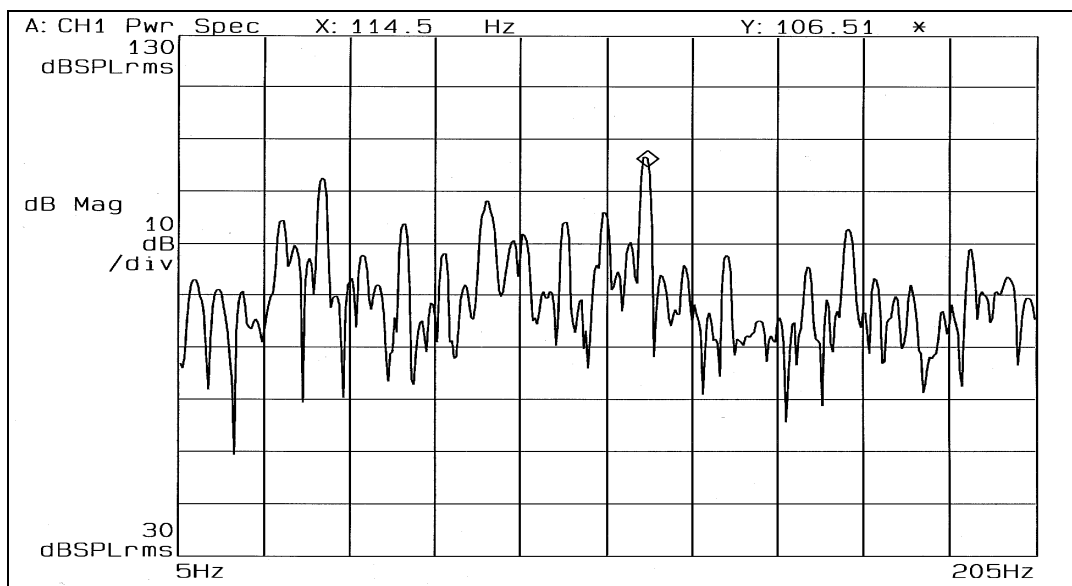
Microphone M-5 was placed inside the vehicle for the purpose of monitoring compartment noise. Isolation techniques were employed so that the microphone would not come in contact with neighboring vibrating surfaces. The acoustic signature shows that it is similar in value to the data from the buried microphones. See Figure 3-6.

**Figure 3-6. Acoustic Data Sample from Microphone M-5 Shows SA-6 Radar Vehicle Engine Signature Prior to Warhead Detonation.**

The time is now 13:49:11. Acoustics (M-5) inside the vehicle compartment have changed. The engine firing frequency is now 117.00 Hz. This is an increase of 3.0 Hz over the former engine idle value of 114.00 Hz. Harmonic distortion is evident in the acoustic signature. Formerly clean peaks observed in Figure 3-6 now have side harmonics. See Figure 3-10.

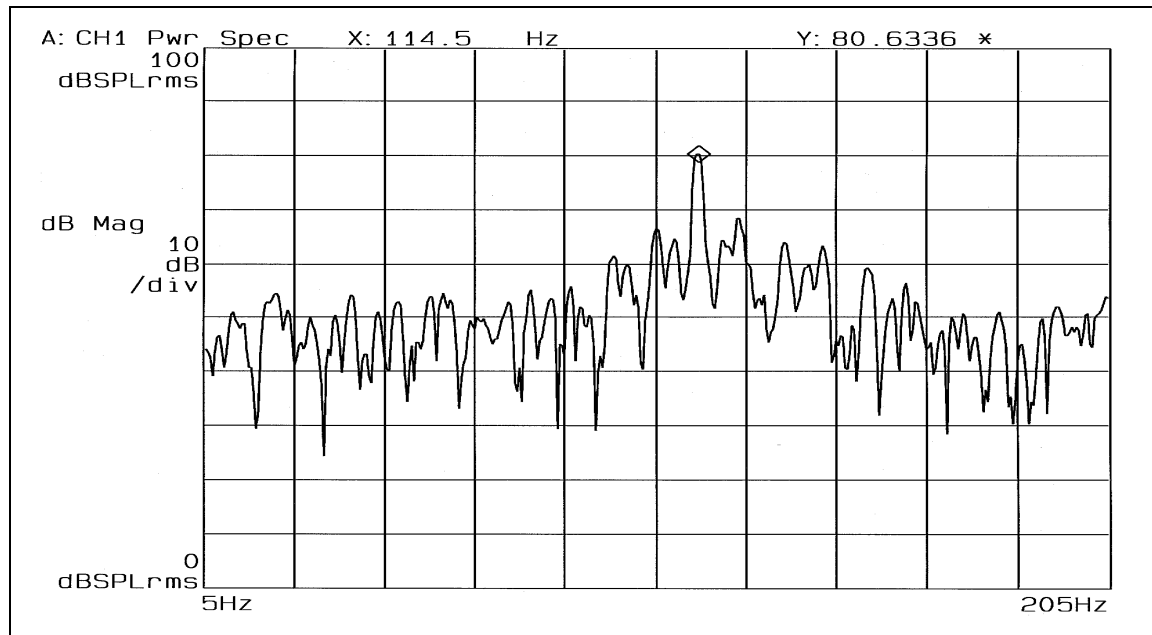
Microphone M-6, was the soaker hose microphone. This device was placed directly on the ground surface. Its operation is dependent on the length of a rubber hose that has random perforations. The soaker hose is used as a windscreen to minimize background noise. Figure 3-7 shows the SA-6 Radar acoustic signature. The engine firing frequency remains stable at 114.5 Hz. However, a decrease of sound pressure level is observed, 80.6dB. Two factors have contributed to the SPL attenuation. These are distance to the vehicle and the soaker hose windscreen.

**Figure 3-7 Acoustic Data Sample from Microphone M-6 Shows SA-6 Radar Vehicle Engine Signature Prior to Warhead Detonation.**

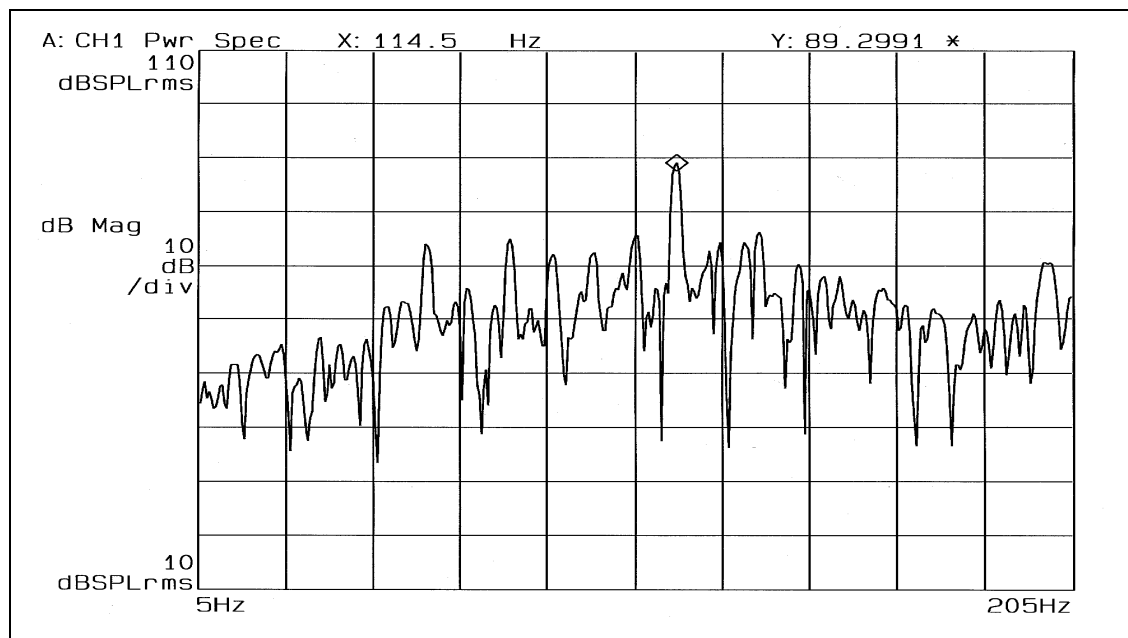
Microphones M-7 and M-8 were collocated with the soaker hose and the buried microphones respectively. The acoustic signatures of these are shown in Figures 3-8 and 3-9 respectively. No evident change is observed in the engine firing frequency. Average SPL is 87.0dB. Comparing the SPL level of these two microphones against the buried acoustic sensors M-1, M-2 and M-3 shows a SPL level difference of at least 20dB. The soil properties at the test site contributed little to none in the form of signal SPL attenuation.

**Figure 3-8 Acoustic Data Sample from Microphone M-7 Shows SA-6 Radar Vehicle Engine Signature Prior to Warhead Detonation**

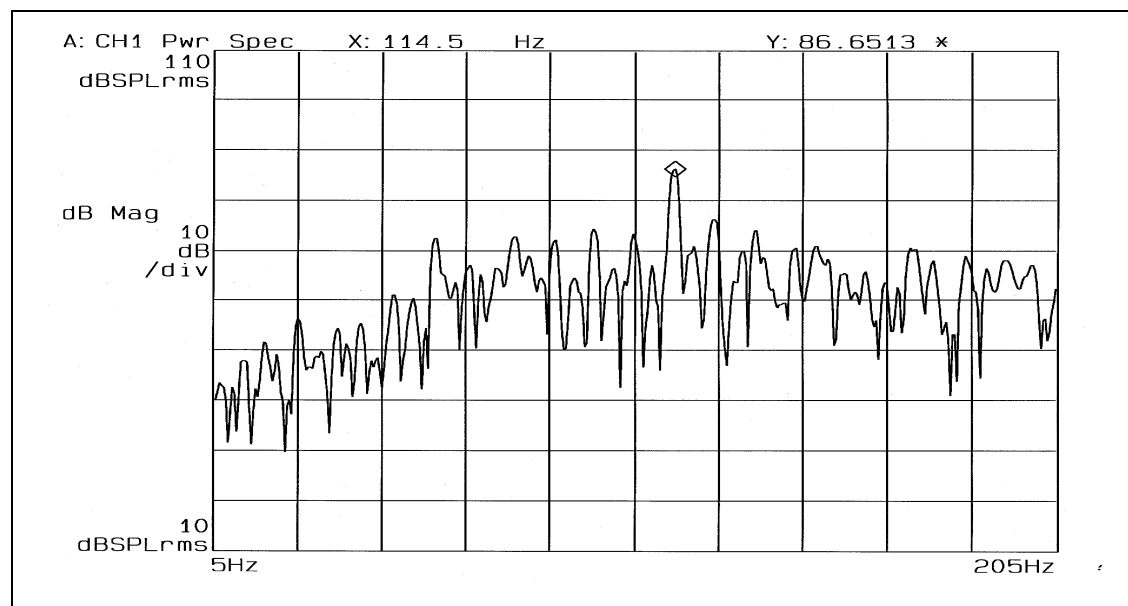
**Figure 3-9 Acoustic Data Sample from Microphone M-8 Shows SA-6 Radar Vehicle Engine Signature Prior to Warhead Detonation**

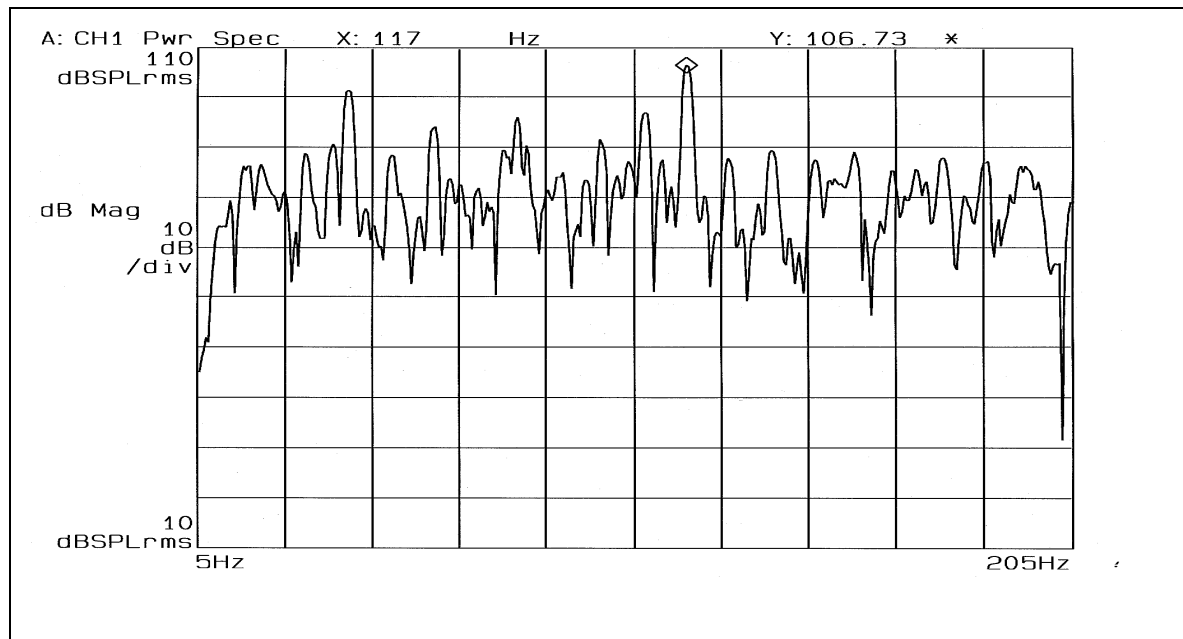
**Figure 3-10 Acoustic Data Sample from Microphone M-5 Shows SA-6 Radar Vehicle Engine Signature After Warhead Detonation. Time 13:49:11**

During the period of 13:49:11 to 13:49:15, the engine firing frequency fluctuated between 117.00 Hz and 117.50 Hz. Periods of distortion were evident in the acoustic spectra. This caused the engine revolutions

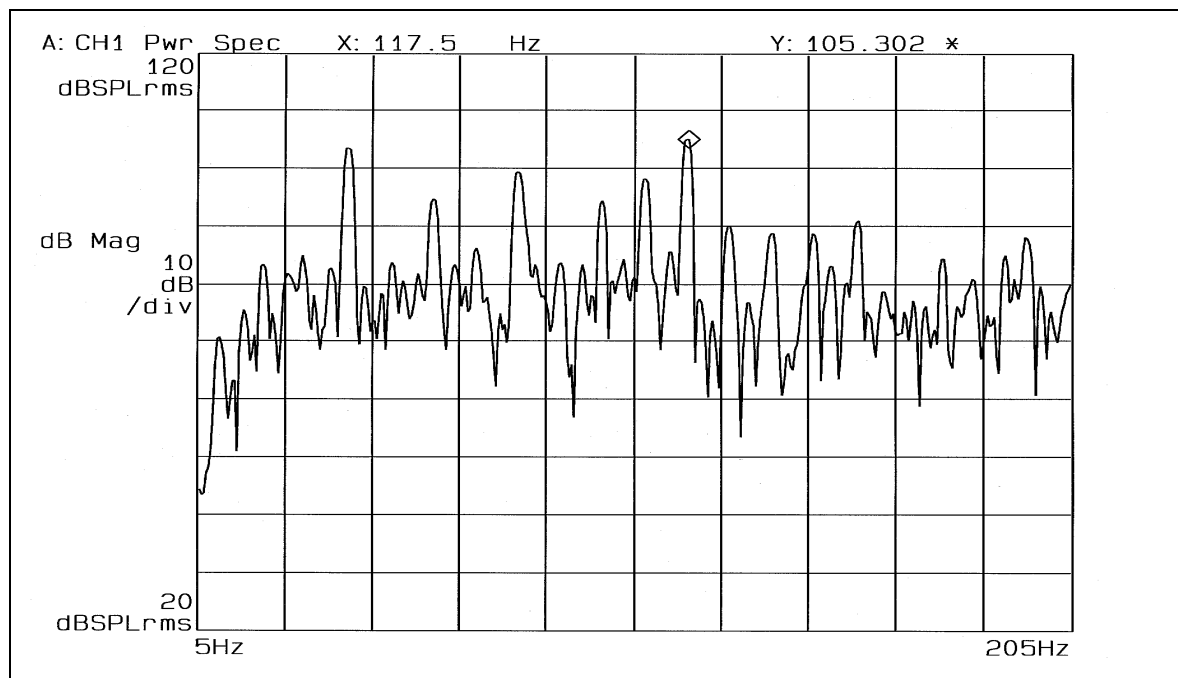
The time is now 13:49:13. Acoustics (M-5) inside the vehicle compartment show that the engine firing frequency is 117.50 Hz. The harmonic distortion of the spectra has dropped to the floor noise area. See Figure 3-11.

**Figure 3-11 Acoustic Data Sample from Microphone M-5 Shows SA-6 Radar Vehicle Engine Signature After Warhead Detonation. Time 13:49:13**

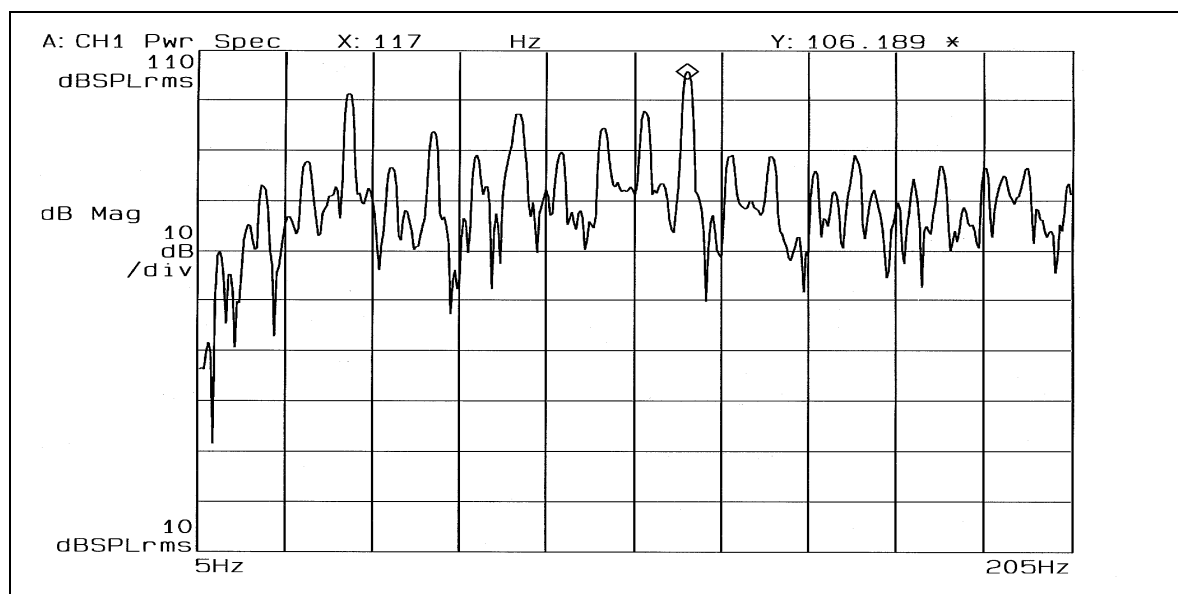
The time is now 13:49:15. Acoustics (M-5) inside the vehicle compartment show that the engine firing frequency is 117.00 Hz. Harmonic content of the spectra has increased in value once more. See Figure 3-12.

**Figure 3-12 Acoustic Signature from Microphone M-5 Shows SA-6 Radar Vehicle Engine Signature After Warhead Detonation. Time 13:49:15**

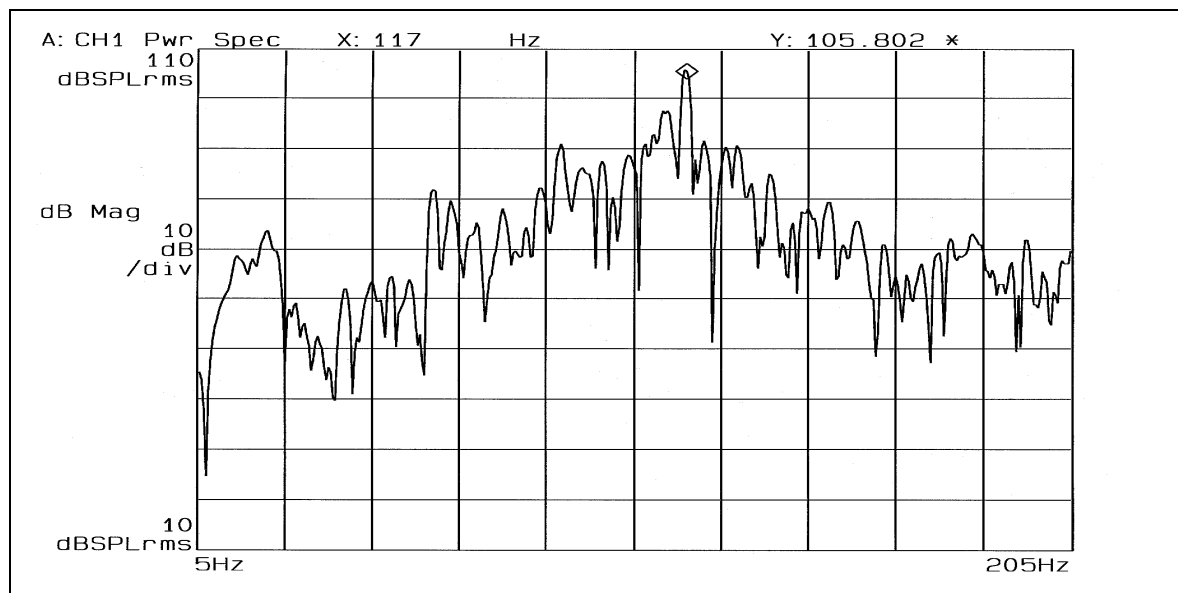
The time is 13:48:38. Microphone M-1 data shows that the engine firing frequency is 117.00 Hz and SPL is 105.80dB. Distortion of the acoustic data sample is visible in Figure 3-13.

**Figure 3-13 Acoustic Data Sample from Microphone M-1 Shows SA-6 Radar Vehicle Signature After Warhead Detonation. Time 13:48:38**

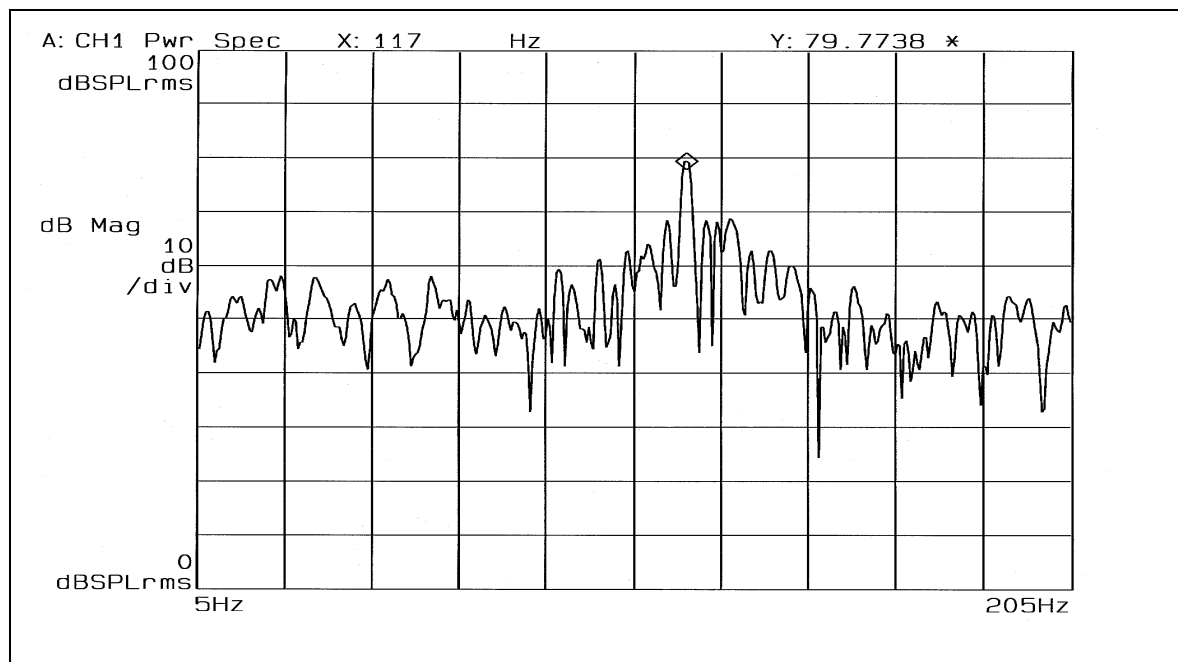
The time is 13:48:41. The acoustic data sample from microphone M-6 shows that the engine firing frequency remains the same and SPL is 79.77dB. The SPL attenuation is due to the inherent characteristics of the soaker hose windscreen. Signal distortion remains evident. See Figure 3-14.

**Figure 3-14 Acoustic Data Sample from Microphone M-6 Shows SA-6 Radar Vehicle Engine Signature After Warhead Detonation. Time 13:48:41**

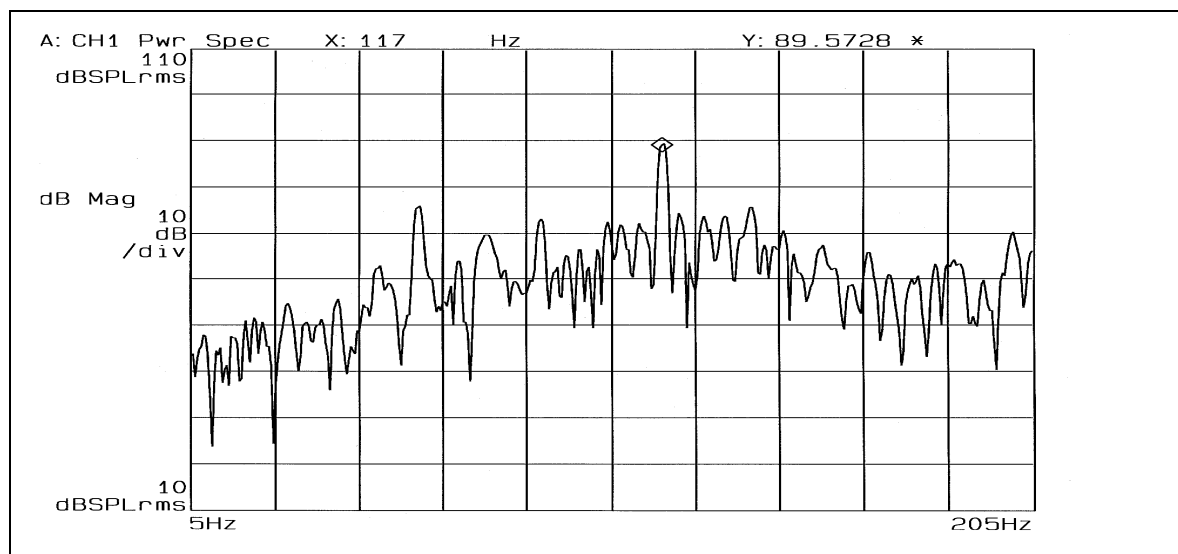
The time is 13:48:42. This acoustic data sample is from microphone M-7. This device was collocated with the soaker hose. The engine firing frequency is 117.00 Hz and the SPL is 89.57dB. See Figure 3-15.

**Figure 3-15 Acoustic Data Sample from Microphone M-7 Shows SA-6 Radar Vehicle Engine Signature After Warhead Detonation. Time 13:48:42**

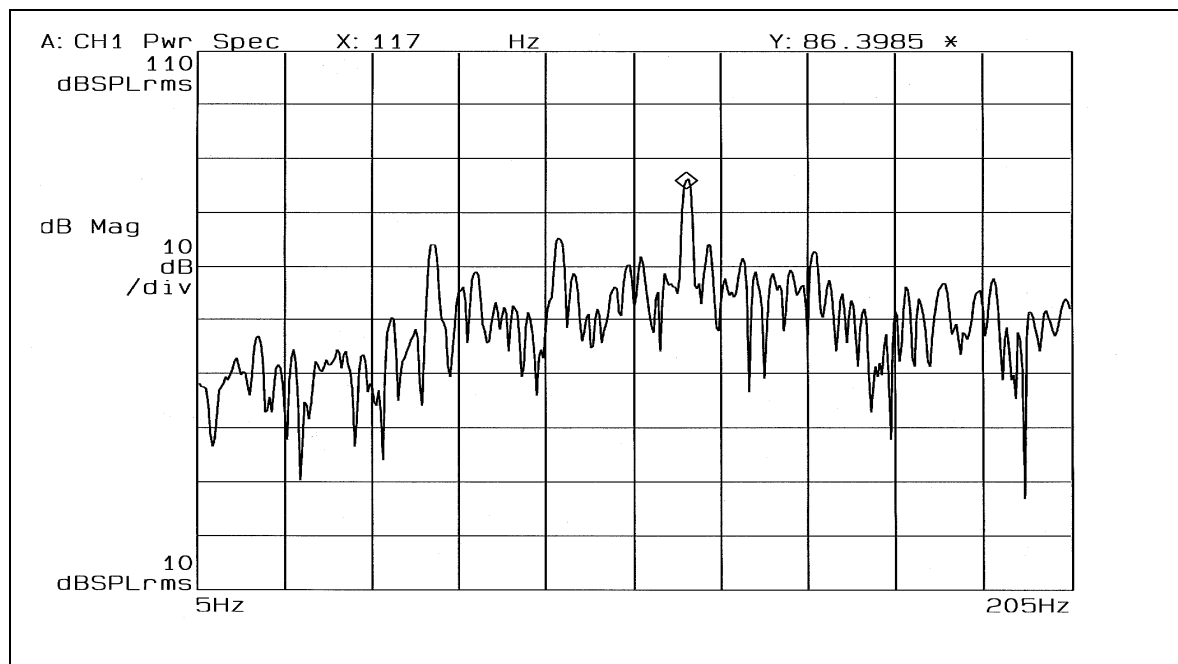
Figure 3-16 shows the acoustic signature at 13:48:43. This sample was from microphone M-8. This device was collocated with the buried microphones. The data product is similar to that from microphone M-7.

**Figure 3-16 Acoustic Data Sample from Microphone M-8 Shows SA-6 Radar Vehicle Engine Signature After Warhead Detonation. Time 13:48:43**

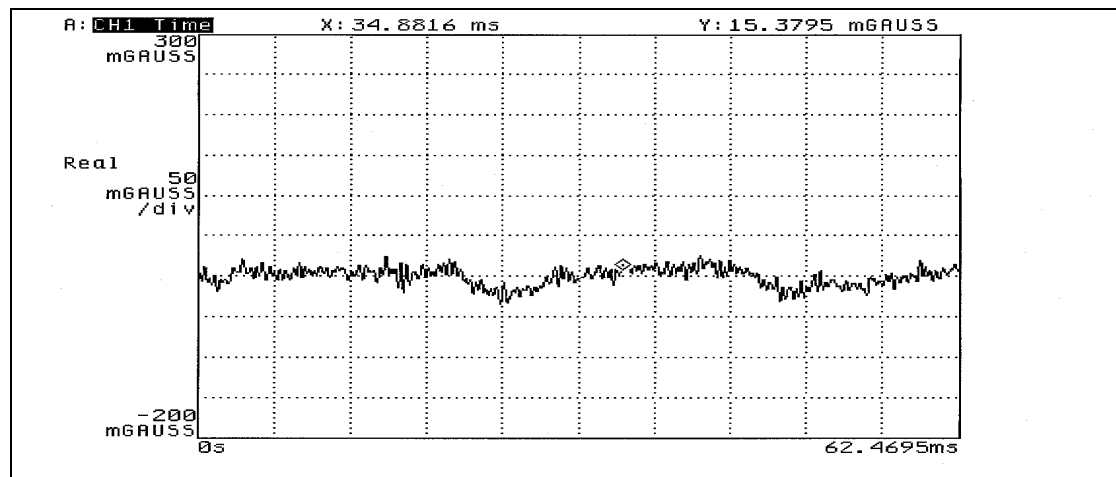
A sampling of magnetic background noise was acquired to establish a baseline. This sample was collected with the SA-6 Radar vehicle stationary and all systems off. Figure 3-17 shows that the average background was 15.0 mGauss.

Figure 3-17 Sample of Magnetic Background Noise from the Meppen Test Site

**4.3.1 Magnetic:** Magnetic data samples show that the background noise at the Meppen site averaged 15.0 mGauss excluding the earth's magnetic field.

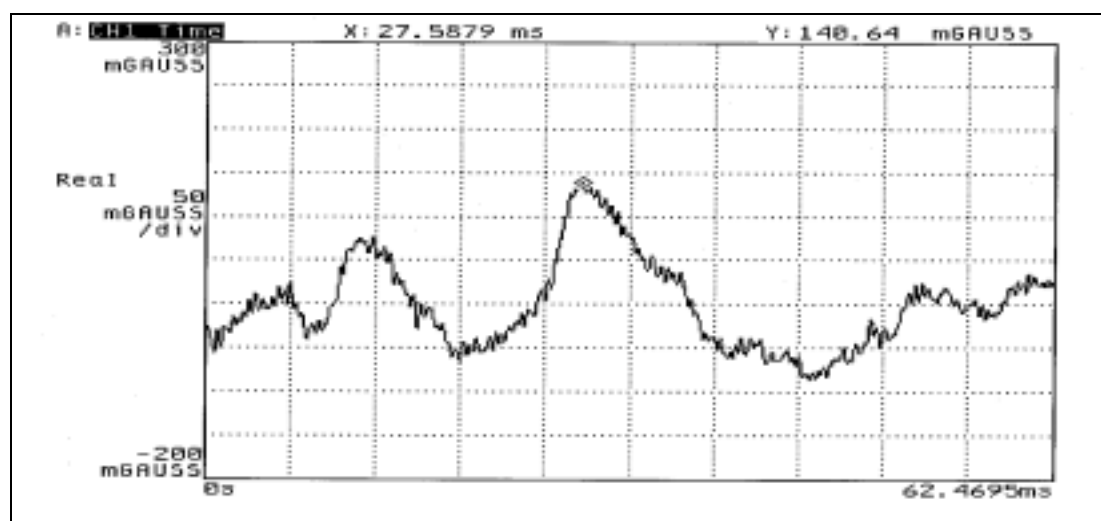
The SA-6 Radar vehicle is now in operation and the radar is emanating 1 Watt of power. It must be noted that the magnetometer is sampling the backside of the SA-6 Radar dish. Figure 3-18 shows that the magnetic levels now average 130.0 mGauss.

**Figure 3-18 Magnetic Data Sample from the Backside of the SA-6 Radar Vehicle, Prior to the Warhead Detonation**

**4.3.2 Magnetic:** Magnetic data samples from the backside of the active SA-6 Radar transmitter, show an average value of 130.00 mGauss prior to the warhead detonation.

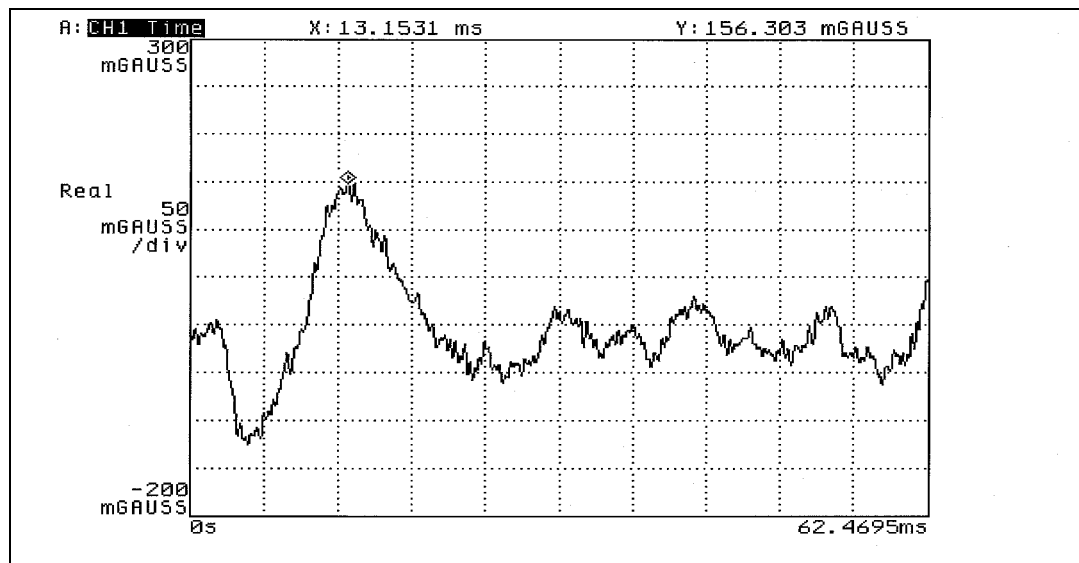
The HARM warhead detonation has taken place. Magnetic effects from the warhead detonation are added to the radar's magnetic field. Figure 3-19 shows the magnetic data sample immediately after the detonation.

**Figure 3-19 Magnetic Data Sample from the Backside of the SA-6 Radar Vehicle, Five Seconds after Warhead Detonation**

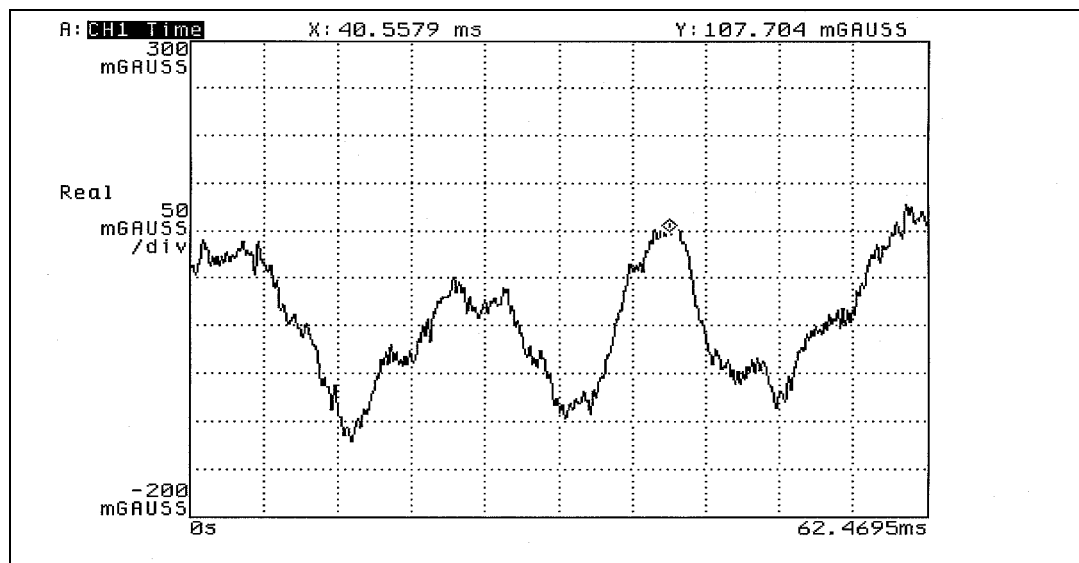
The radar begins to show signs of magnetic decay. Emanations begin to decrease rapidly. The signature begins to show random attempts by the vehicle electrical systems to compensate. See Figure 3-20.

**Figure 3-20 Magnetic Data Sample from the Backside of the SA-6 Radar Vehicle, Seven Seconds after Warhead Detonation**

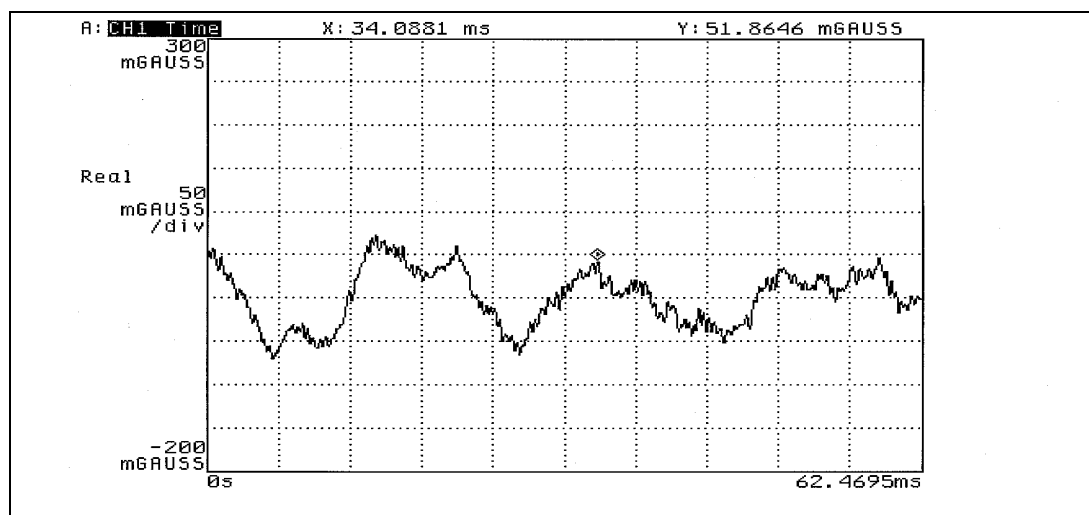
The radar continues to show significant signs of magnetic decay. Emanations are now at a very low level. The signature continues to show a random effect. See Figure 3-21.

**Figure 3-21 Magnetic Data Sample from the Backside of the SA-6 Radar Vehicle, Eleven Seconds after Warhead Detonation**

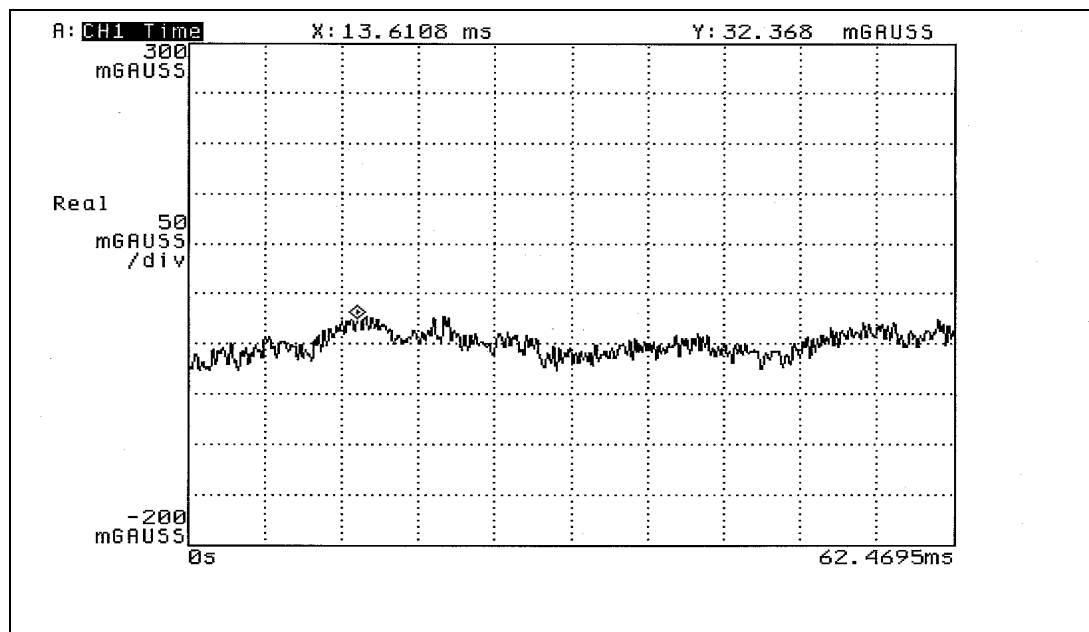
The magnetic signature from the SA-6 Radar on-board moment is now approaching the background noise baseline value of 15.0 mGauss. See Figure 3-22.

**Figure 3-22 Magnetic Signature from the Backside of the SA-6 Radar Vehicle, Thirty Seven Seconds after Warhead Detonation**
